Stream Habitat Assessment and Wetland Delineation Report

**Joes Run Mine Site
Daviess County, Kentucky**

September 17, 2012

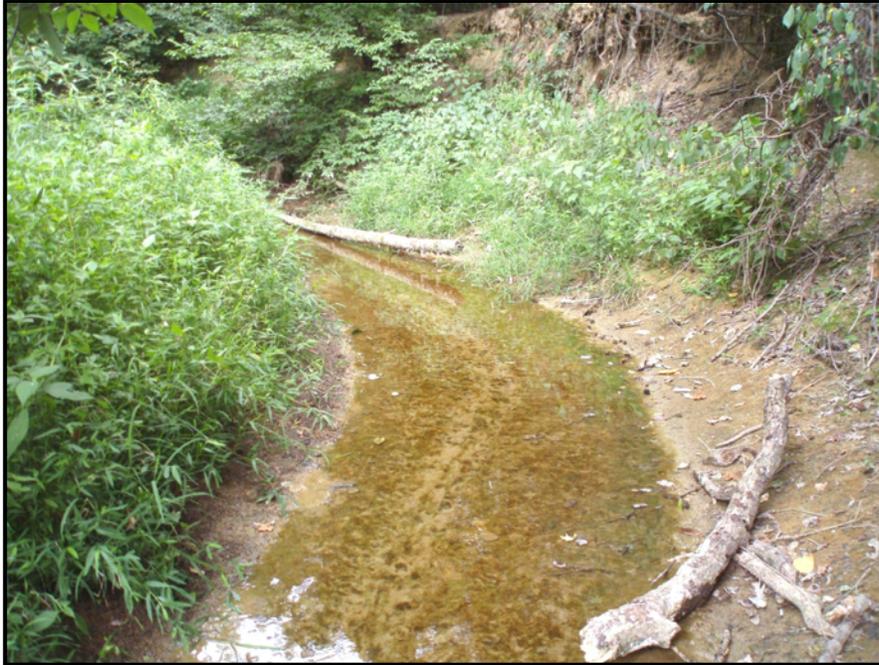
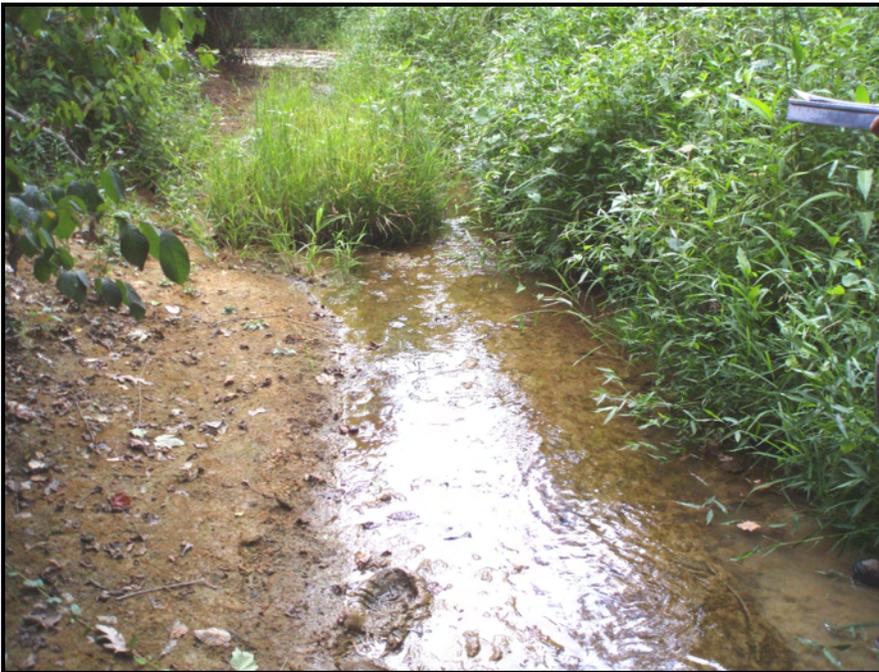
P-1 has a total habitat score of 94, corresponding to a stream quality rating of marginal. A conductivity reading was taken, yielding 1530 μ S. P-1 is classified, according to Rosgen methodology, as an "F6" type stream.

Perennial 1 (P-1) – Looking upstream

Perennial 1 (P-1) – Looking downstream

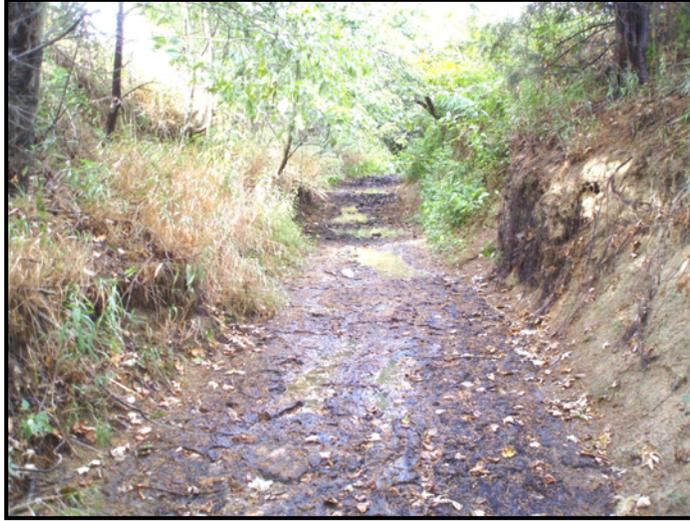
The stream habitat assessment (Low Gradient) for the downstream section (I-1DS) indicates a epifaunal substrate/available cover score in the marginal range. The substrate consists of mostly silt/clay size material, with some traces of gravel present. Streambed morphology consists of long runs and very short pool sections (mostly shallow). At the time of assessment, flow was not utilizing much of the wide channel bottom. There is little evidence of deposition of new fine material in this reach. Again, there is evidence of past channelization, but nothing recent was found (this segment continues straight through agricultural lands, with sinuosity scoring in the poor range). Bank stability scored as moderately unstable for both banks, with areas of erosion present. Vegetative protection scored in the marginal range, while the riparian zone width once again scoring poor (due to agricultural practices).

Intermittent 1 (I-1 DS) – Looking upstream

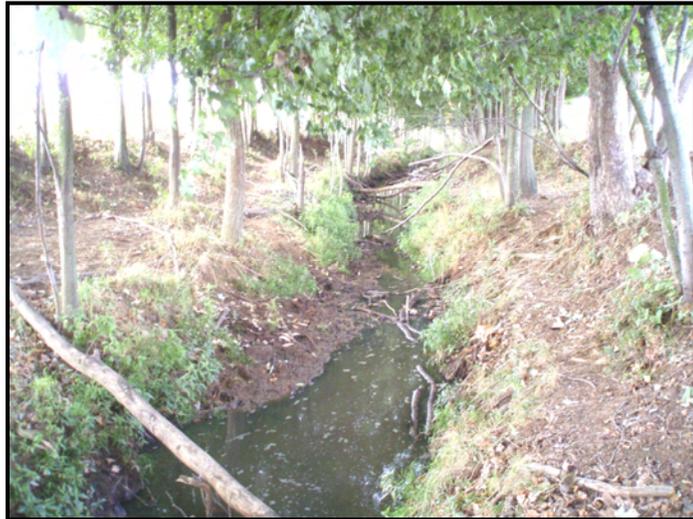
The stream habitat assessment (Low Gradient) for the midstream section (I-1MS) indicates a epifaunal substrate/available cover score in the low suboptimal range. Again, the

substrate consists of only silt/clay size material. Streambed morphology consists of equal runs and pool sections (some large and/or deep pools present). At the time of assessment, flow was utilizing over 75 percent of the channel bottom. There is evidence of moderate deposition of new fine material. Evidence of past channelization is present, but no recent evidence was found (segment runs straight through agricultural lands, with sinuosity scoring in the poor range). Bank stability scored as moderately stable for both banks, with infrequent areas of erosion present. Vegetative protection scored in the marginal range, while the riparian zone width again scored poor (due to agricultural practices).

Intermittent 1 (I-1 MS) – Looking downstream

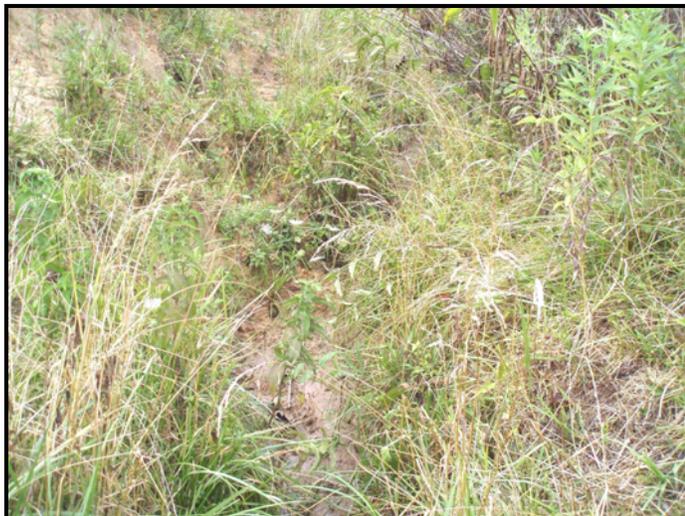
The EPA stream habitat assessment (Low Gradient) for the upstream section (I-1US) indicates a epifaunal substrate/available cover score in the marginal range. The substrate consists of silt/clay size material. Streambed morphology consists of only long runs. At the time of assessment, there was little flow in the channel. There was evidence of moderate deposition of new fine material. There was evidence of past channelization, but no recent evidence was found (this stream segment starts at a culvert under Aull Road and runs through pasture). Sinuosity scored in the poor range. Bank stability scored in the low marginal (moderately unstable) range for both banks, with obvious erosion problems present. Vegetative protection scored in the high marginal to low suboptimal range, while the riparian zone width scored poor (due to agricultural practices).

Intermittent 1 (I-1 US) – Looking downstream

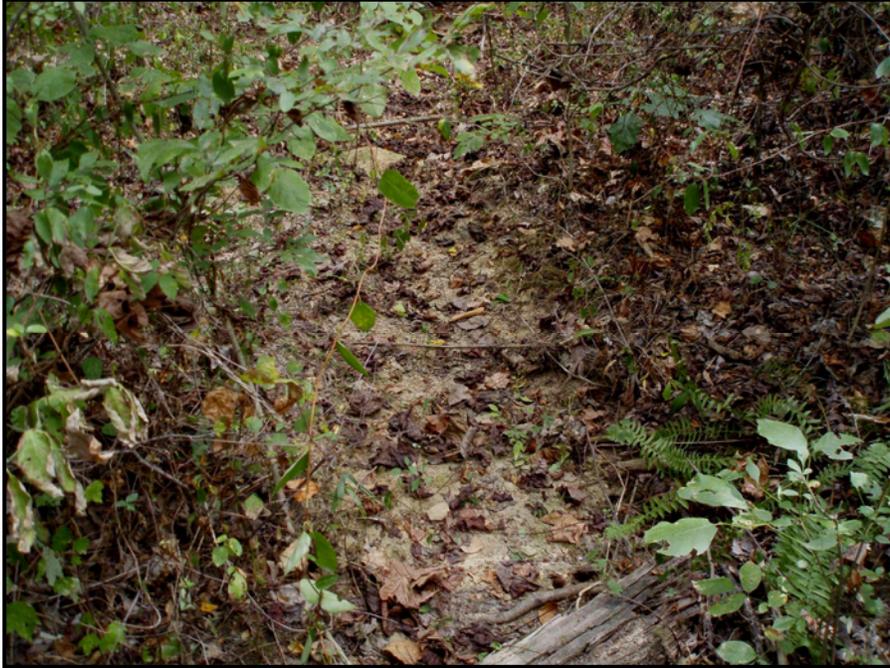
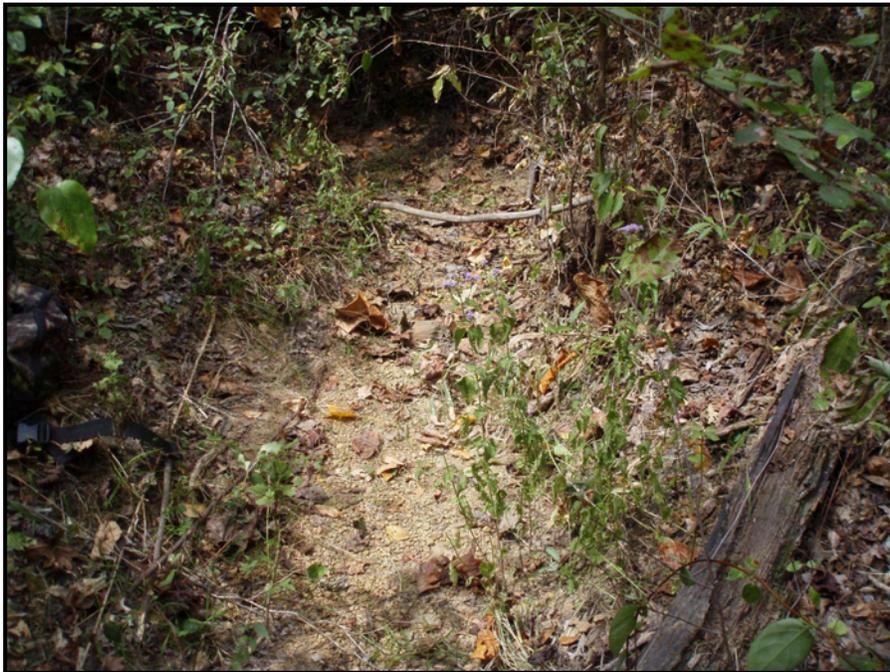
The habitat assessment (Low Gradient) for I-2 indicates the epifaunal substrate/available cover scored in the suboptimal range. The streambed morphology consists of short riffles and runs, with longer pool sections. The substrate in the riffles and runs consisted of silt/clay and gravel size material, while pools appeared to be only silt/clay material. At the time of assessment, little flow was utilizing the channel bottom (flow controlled upstream off-site by an impoundment). There was evidence of moderate deposition of new fine material, affecting 50 to 80 percent of the bottom. Past channelization may have occurred, resulting in the sinuosity score being in the low suboptimal range. Bank stability scored as moderately unstable, with 30

to 60 percent of the banks having areas of erosion. The vegetative protection score was in the suboptimal range, while the riparian zone width scored in the poor range due to agricultural practices (narrow band of trees left along the banks).

I-2 has a total habitat score of 87, corresponding to a stream quality rating of marginal. A conductivity readings was not taken. I-2 is classified, according to Rosgen methodology, as an “F6” type stream.

Intermittent 2 (I-2) – Looking upstream

Intermittent 2 (I-2) – Looking downstream

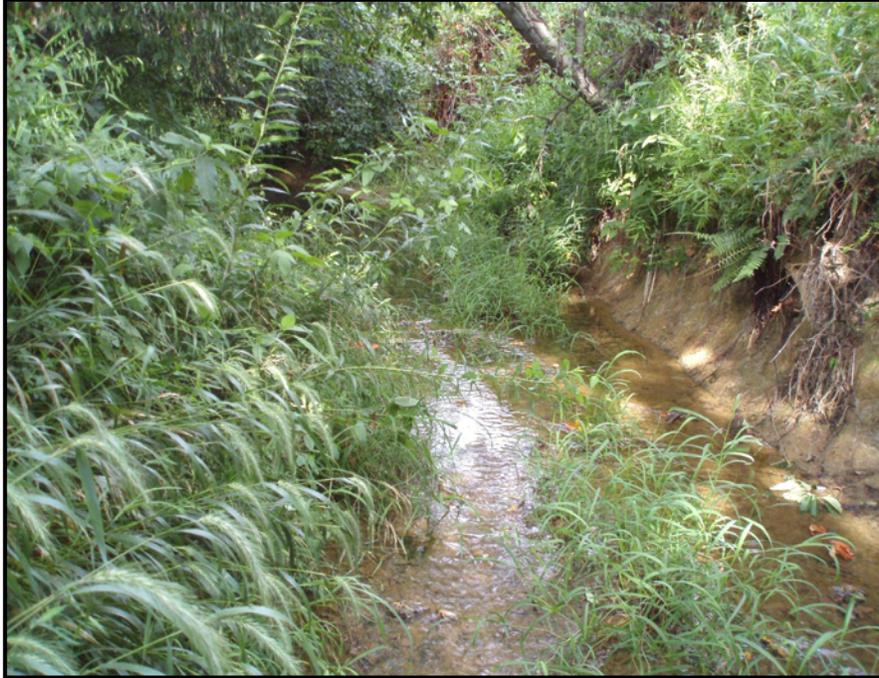
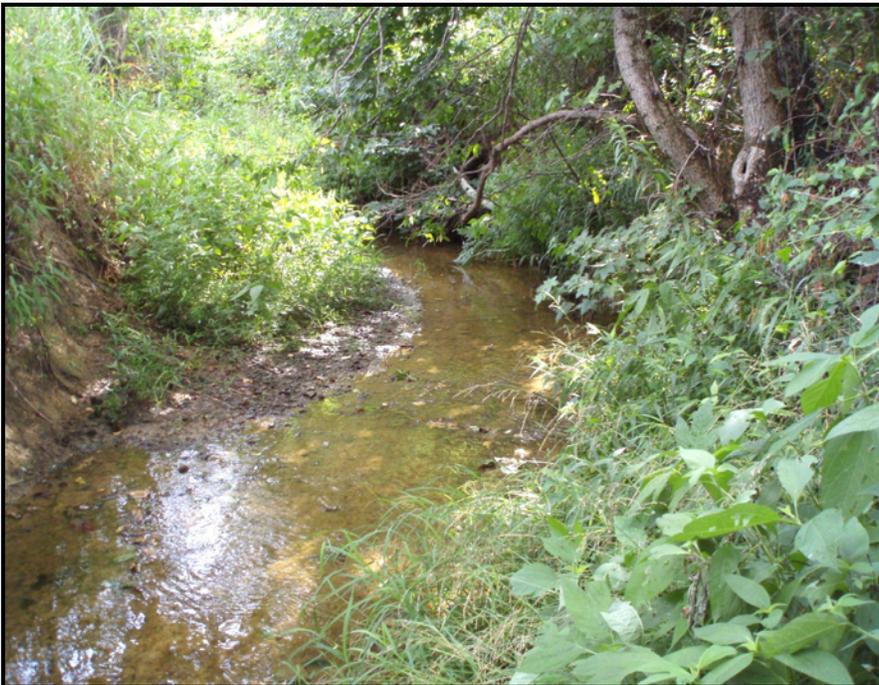
Intermittent Stream 3 (I-3) is located in the southern portion of the study area and is a tributary to P-1. It flows southwest for approximately 684 feet within the study boundary. It has a drainage area of 601.6 acres at its confluence with P-1. The stream has a bottom width of 3.0 feet, and a bankfull width of 9.0 feet. This stream is very incised/entrenched.

Intermittent 3 (I-3) – Looking upstream

Intermittent 3 (I-3) – Looking downstream

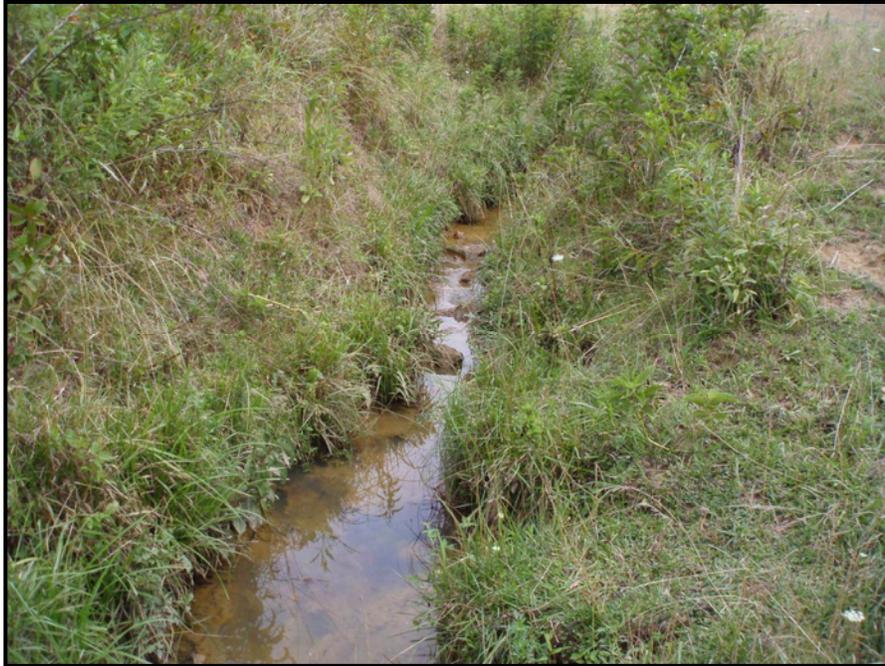
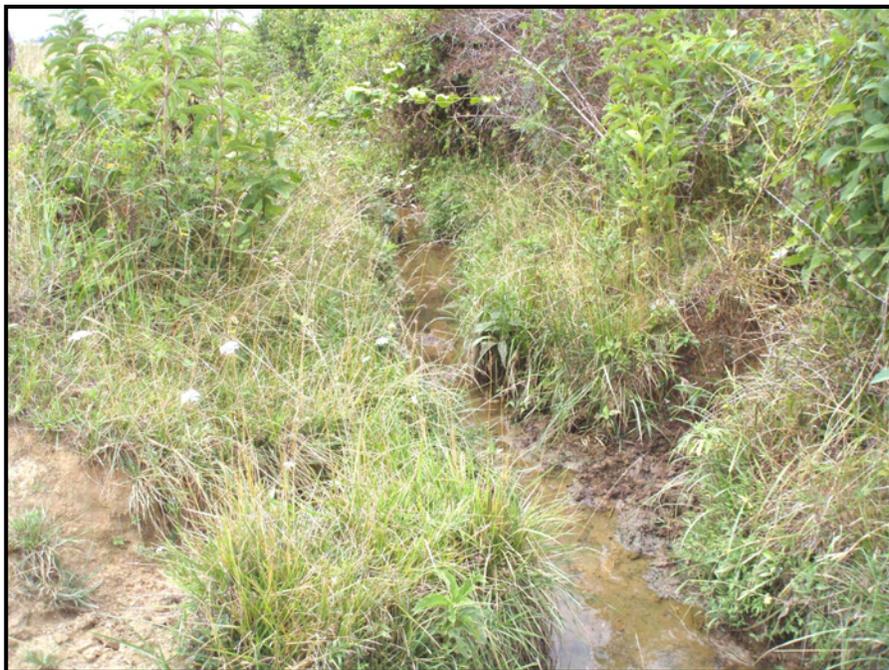
Intermittent 4 (I-4) – Looking upstream

Intermittent 4 (I-4) – Looking downstream

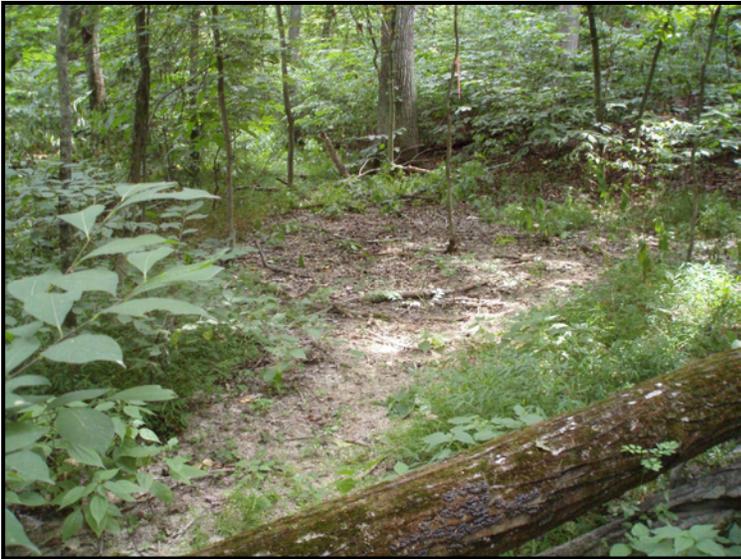
Wetland A – Palustrine Forested

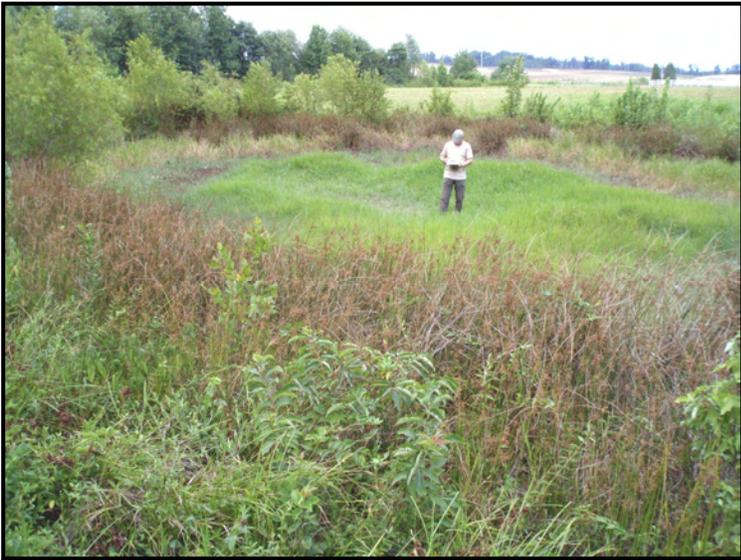
Wetland B – Palustrine Emergent

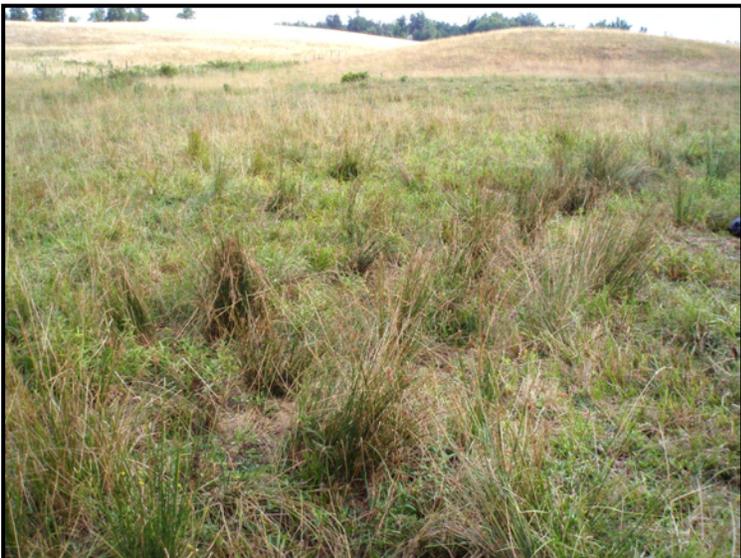
Wetland C – Palustrine Emergent
