# **Stream Habitat Assessment and Wetland Delineation Report**

**P Ridge South Pit Mine, Amend. #1  
Ohio County, Kentucky**

**Western Kentucky Minerals**

January 31, 2012

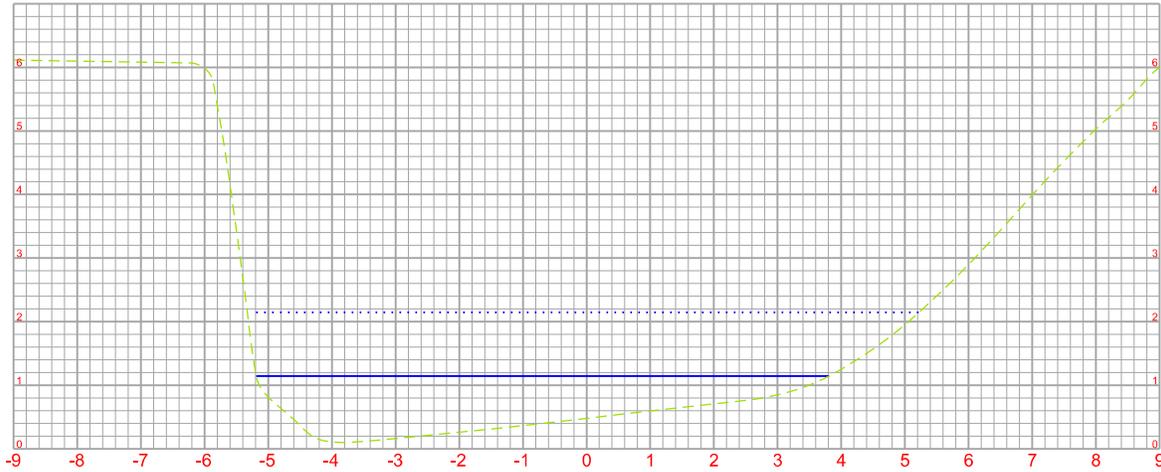
## I-1 DS

BFW = 9.0ft  
 BFD max = 1.0ft  
 FPW = 10.41ft

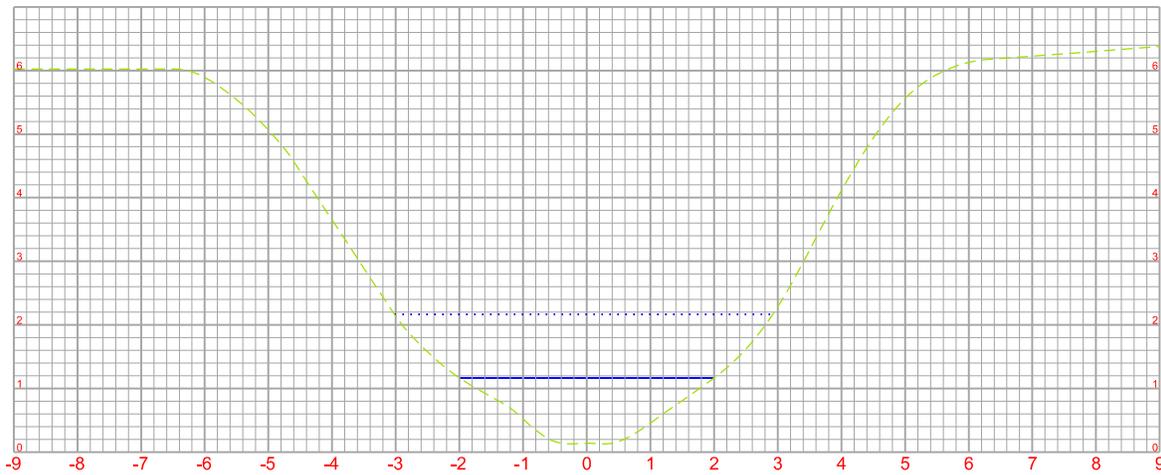
## I-1 US

BFW = 4.0ft  
 BFD max = 1.0ft  
 FPW = 5.93ft

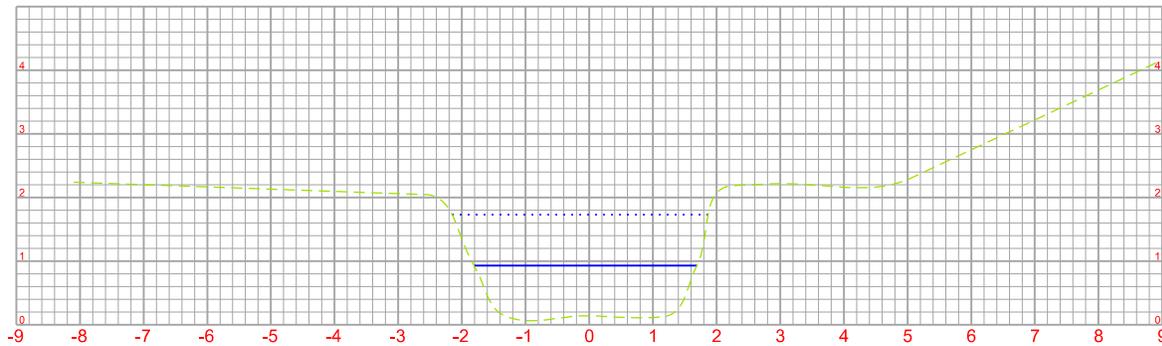
## I-2

BFW = 3.5ft  
 BFD max = 0.8ft  
 FPW = 4.02ft

The EPA stream habitat assessment (Low Gradient) for I-2 indicates an epifaunal substrate/available cover score in the low suboptimal range. However, the substrate consists of only silt/clay size material. Streambed morphology consists of long runs, and very short pool sections. At the time of assessment, there was little to no flow found in the channel bottom. There was evidence of moderate deposition of new fine material, affecting 50 to 80 percent of the bottom. Some past channelization may have occurred (sinuosity scored poor), but no recent evidence was found. Bank stability scored in the suboptimal range for the left bank (moderately stable) and high marginal for the right bank (moderately unstable). Vegetative protection scored in the marginal range, while the riparian zone width scored suboptimal. The dominant riparian vegetation typically consists of trees, shrubs, and herbaceous species.

I-2 has a total habitat score of 97, corresponding to a stream quality rating of marginal. A conductivity reading was not taken due to dry conditions. I-2 is classified, according to Rosgen methodology, as an “G” type stream.

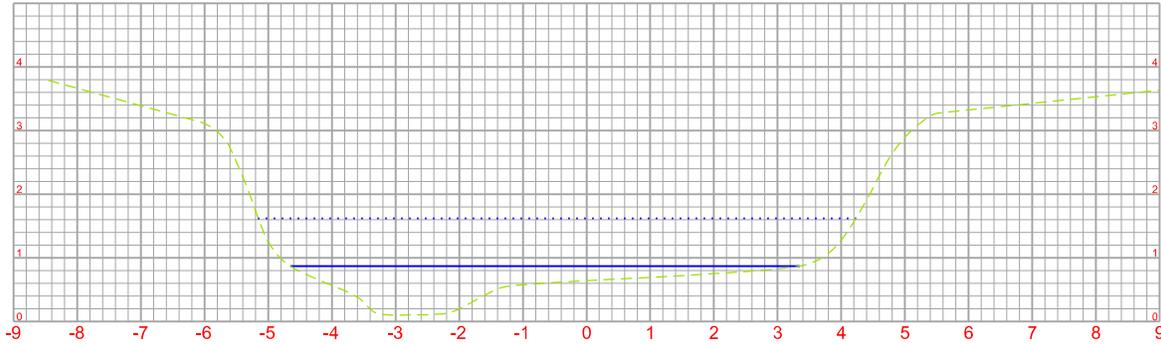
## E-1 DS

BFW = 8.0ft  
 BFD max = 0.75ft  
 FPW = 9.40ft

The stream habitat assessment (Low Gradient) for the downstream reach (E-1DS) indicates an epifaunal substrate/available cover score again in the marginal range. Like the upstream section, the substrate consists of only silt/clay size material and the streambed morphology consists of only runs. There was little to no flow found in the channel bottom during the assessment. There was evidence of moderate deposition of new fine material, affecting 50 to 80 percent of the bottom. Again, past channelization may have been extensive resulting in a low marginal sinuosity score. Bank stability scored in the marginal range (moderately unstable). Vegetative protection scored in the marginal for both banks, while the riparian zone width scored suboptimal for both. The dominant riparian vegetation typically consists of trees, shrubs, and herbaceous species.

E-1 has an average total habitat score of 84, corresponding to a stream quality rating of marginal. Conductivity readings were not taken due to dry conditions. E-1 is classified, according to Rosgen methodology, as an "F" type stream for both reaches.

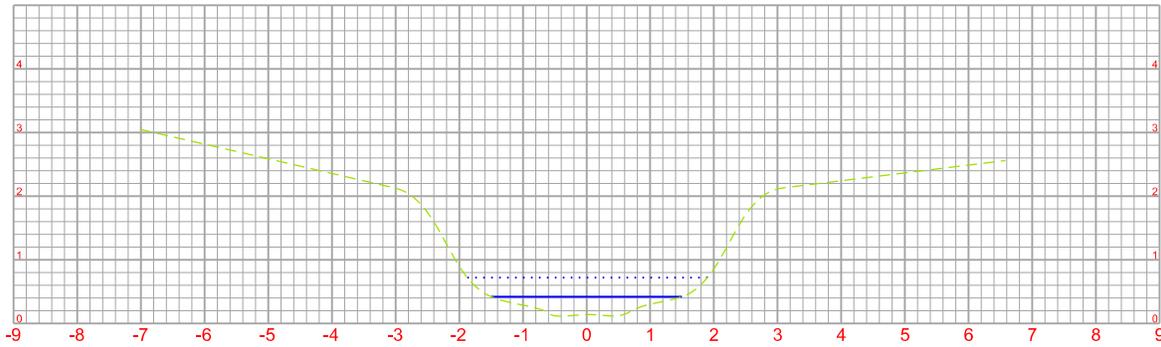
## E-1 US

BFW = 3.0ft  
 BFD max = 0.3ft  
 FPW = 3.77ft

The EPA stream habitat assessment (High Gradient) for the upstream reach (E-1US) indicates an epifaunal substrate/available cover score in the marginal range (less than desirable available habitat). The substrate consists of only silt/clay size material. Streambed morphology consists of only runs. At the time of assessment, there was little to no flow found in the channel bottom. There was evidence of some deposition of new fine material, affecting 5 to 30 percent of the bottom. Past channelization may have been extensive, but no recent evidence was found. Bank stability scored in the marginal range (moderately unstable). Vegetative protection scored in the marginal (left bank) to suboptimal range (right bank), while the riparian zone width scored suboptimal. The dominant riparian vegetation typically consists of trees, shrubs, and herbaceous species.

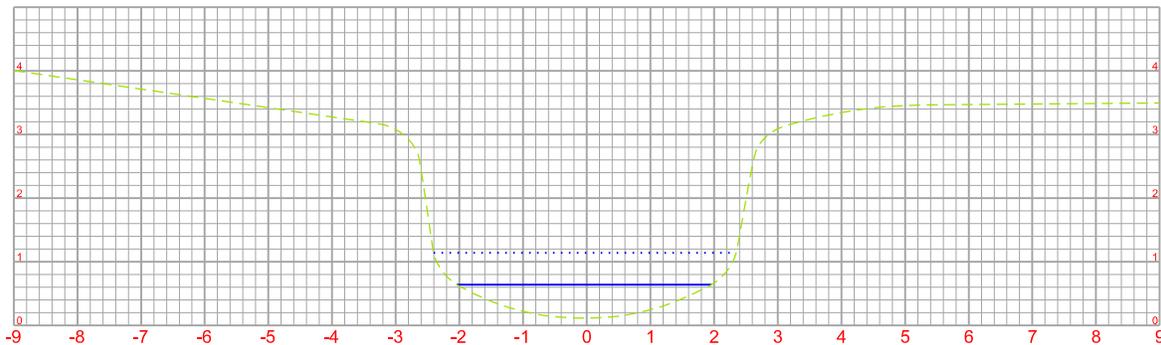
## E-2

BFW = 4.0ft  
 BFD max = 0.5ft  
 FPW = 4.78ft

The EPA stream habitat assessment (High Gradient) for E-2 indicates an epifaunal substrate/available cover score in the marginal range (less than desirable available habitat). The substrate consists of only silt/clay size material and the streambed morphology consists of only runs. At the time of assessment, there was little to no flow found in the channel bottom. There was evidence of some deposition of new fine material, affecting 5 to 30 percent of the bottom. Again, evidence of past channelization that may have been extensive was found. Bank stability scored in the marginal range (moderately unstable). Vegetative protection also scored in the marginal range. The riparian zone width scored suboptimal. The dominant riparian vegetation typically consists of trees, shrubs, and herbaceous species.

E-2 has a total habitat score of 77, corresponding to a stream quality rating of marginal. A conductivity reading was not taken due to dry conditions. E-2 is classified as a "G" type stream.

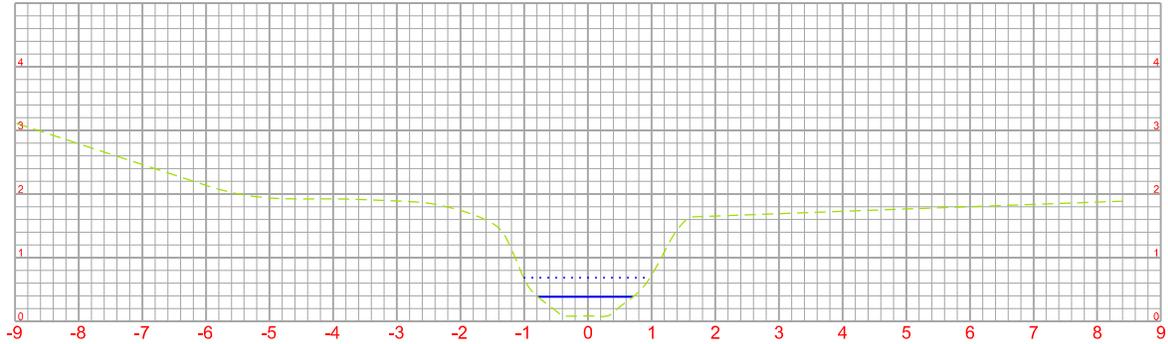
### E-3

BFW = 1.5ft  
 BFD max = 0.3ft  
 FPW = 1.98ft

The EPA stream habitat assessment (High Gradient) for E-3 indicates an epifaunal substrate/available cover score in the marginal range. The substrate consists of only silt/clay size material and the streambed morphology consists of only runs. At the time of assessment, there was little to no flow found in the channel bottom. There was evidence of some deposition of new fine material. There is evidence of some past channelization, but nothing recent. Bank stability scored in the suboptimal range (moderately stable). Vegetative protection also scored in the suboptimal range. The riparian zone width scored suboptimal. The dominant riparian vegetation typically consists of trees, shrubs, and herbaceous species.

E-3 has a total habitat score of 84, corresponding to a stream quality rating of marginal. A conductivity reading was not taken due to dry conditions. E-3 also classified as a "G" type stream.

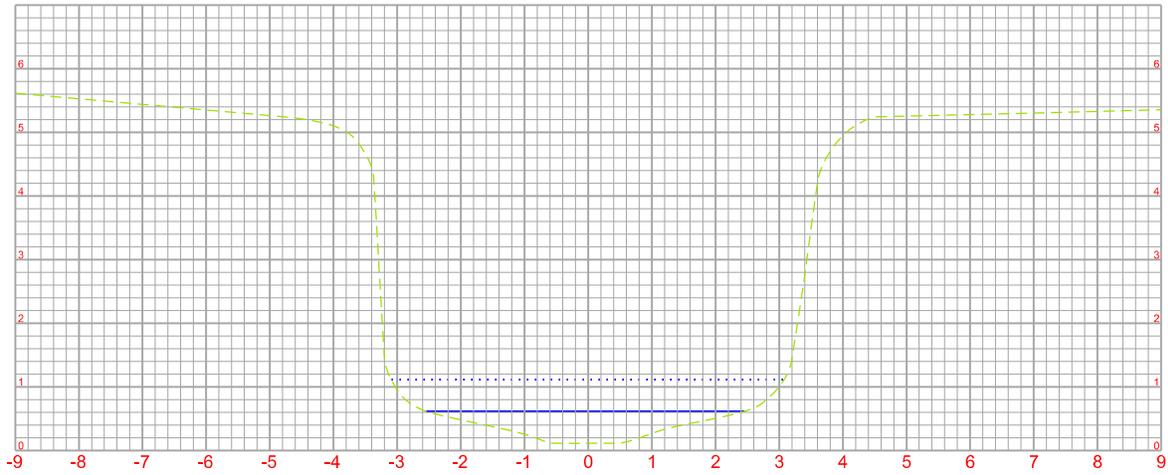
### E-4

BFW = 5.0ft  
 BFD max = 0.5ft  
 FPW = 6.15ft

The stream habitat assessment (High Gradient) for E-4 indicates an epifaunal substrate/available cover score in the high marginal range. The substrate consists of a mix of silt/clay to cobble size materials. The streambed morphology again consists of only runs. There was little to no flow found in the channel bottom at the time of assessment. There was evidence of moderate deposition of new fine material. There is evidence of past channelization that may have been extensive, but nothing recent. Bank stability scored in the marginal range (moderately unstable). Vegetative protection scored in the poor range, with less than 50 percent of the streambank surface covered. The riparian zone width, however, scored suboptimal. The dominant riparian vegetation consisted of trees, shrubs, and herbaceous species.

E-4 has a total habitat score of 66, corresponding to a stream quality rating of low marginal. A conductivity reading was not taken due to dry conditions. E-4 classified as a "G" type stream.

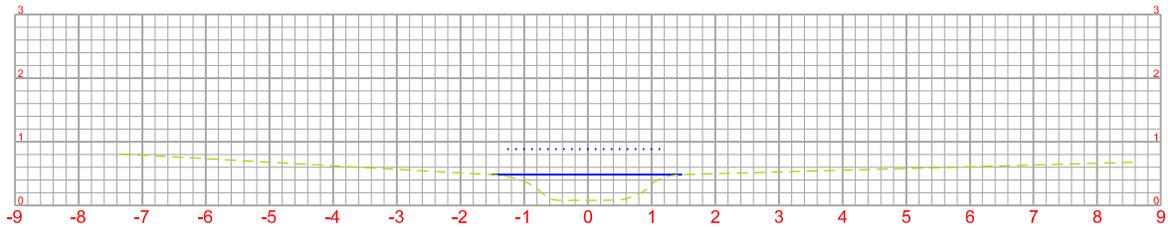
### E-5 DS

BFW = 3.0ft  
 BFD max = 0.4ft  
 FPW = ft

The stream habitat assessment (Low Gradient) for the downstream reach (E-5DS) indicates an epifaunal substrate/available cover score in the marginal range. Like the upper reach, the substrate consists of only silt/clay size material and the streambed morphology consists of only runs. There was little to no flow found in the channel bottom at the time of assessment. There was some evidence of deposition of new fine material affecting 20 to 50 percent of the bottom. There is some evidence of channelization present, but nothing that occurred recently; with sinuosity scoring in the low marginal range. Bank stability again scored in the optimal range (stable with minimal evidence of erosion), but vegetative protection scored in the suboptimal range (with 70 to 90 percent of the streambank surface covered). The riparian zone width scored low suboptimal. The dominant riparian vegetation again consisted of trees, shrubs, and herbaceous species.

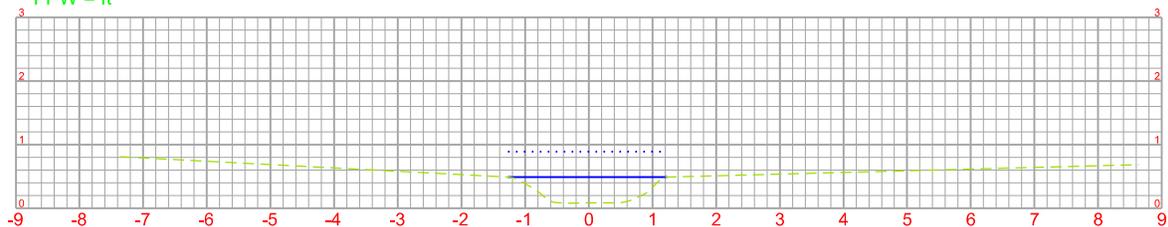
### E-5 US

BFW = 2.5ft  
 BFD max = 0.4ft  
 FPW = ft

The stream habitat assessment (Low Gradient) for the upstream reach (E-5US) indicates an epifaunal substrate/available cover score in the low suboptimal range. The substrate consists of only silt/clay size material and the streambed morphology consists of only runs. There was little to no flow found in the channel bottom at the time of assessment. There was little evidence of deposition of new fine material. There is some evidence of channelization present, but nothing that occurred recently. Sinuosity scored in the low suboptimal range. Bank stability scored in the optimal range (stable with minimal evidence of erosion). Vegetative protection also scored in the optimal range, with more than 90 percent of the streambank surface covered. The riparian zone width, however, scored marginal (right bank) to suboptimal (left bank). The dominant riparian vegetation again consisted of trees, shrubs, and herbaceous species. The channel is nearly indistinguishable in this reach.

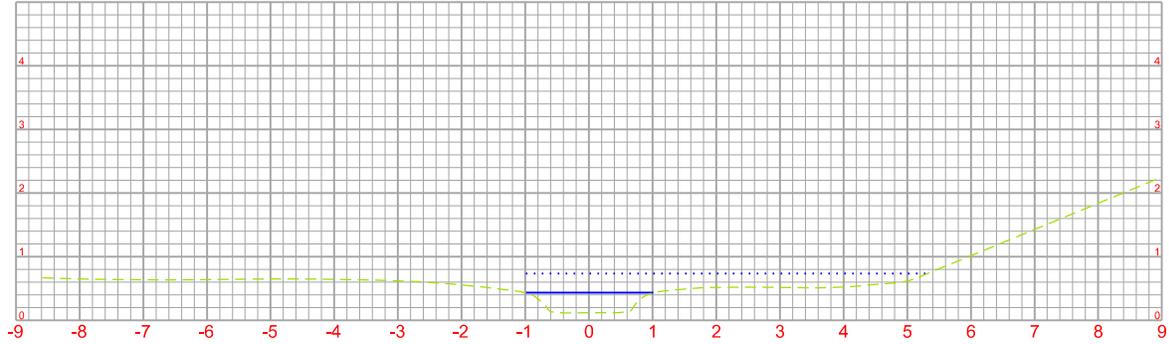
## E-6

BFW = 2.0ft  
 BFD max = 0.3ft  
 FPW = ft

The stream habitat assessment (Low Gradient) for E-6 indicates an epifaunal substrate/available cover score in the poor range. The substrate consists of predominantly silt/clay size material, with some sand sizes available. The streambed morphology consists of only runs. There was no flow found in the channel bottom at the time of assessment. There was some evidence of deposition of new fine material. There was also some evidence of

E-6 has a total habitat score of 94, corresponding to a stream quality rating of marginal. A conductivity reading was not taken due to dry conditions. E-6 classified as a “B” type stream.

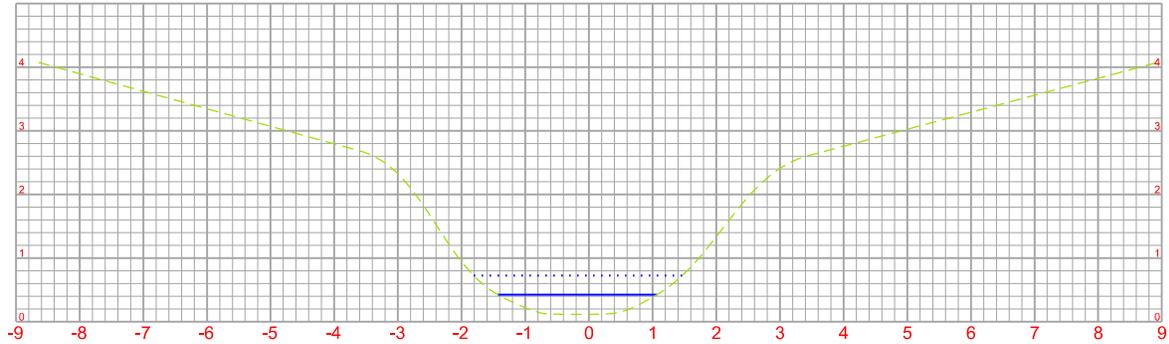
## E-7

BFW = 2.5ft  
 BFD max = 0.3ft  
 FPW = 3.27ft

The stream habitat assessment (High Gradient) for E-7 indicates an epifaunal substrate/available cover score in the marginal range. The substrate consists of only silt/clay size material and the streambed morphology consists of only runs. There was no flow found in the channel bottom at the time of assessment. There was some evidence of deposition of new fine material. There was also some evidence of channelization present. Bank stability scored in the suboptimal range (moderately stable with infrequent evidence of erosion). Vegetative protection also scored in the suboptimal range, with 70 to 90 percent of the streambank surface covered. The riparian zone width scored marginal (left bank) to low suboptimal (right bank). The dominant riparian vegetation consisted of trees, shrubs, and herbaceous species.

E-7 has a total habitat score of 94, corresponding to a stream quality rating of marginal. A conductivity reading was not taken due to dry conditions. E-7 classified as an “F” type stream.

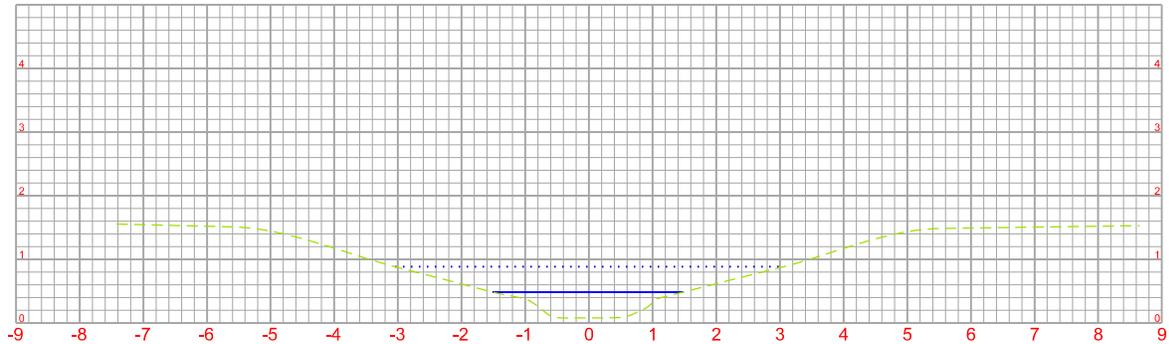
## E-8

BFW = 3.0ft  
 BFD max = 0.4ft  
 FPW = 6.10ft

The stream habitat assessment (Low Gradient) for E-8 indicates an epifaunal substrate/available cover score in the suboptimal range. The substrate consists of only silt/clay size material. The streambed morphology consists of long runs and very short shallow pool sections. There was flow found in the channel bottom, bank to bank, at the time of assessment. There was little evidence of the deposition of new fine material. There was little evidence of past channelization found, but sinuosity still scored marginal. Bank stability scored in the optimal range (stable with little evidence of erosion). Vegetative protection also scored in the

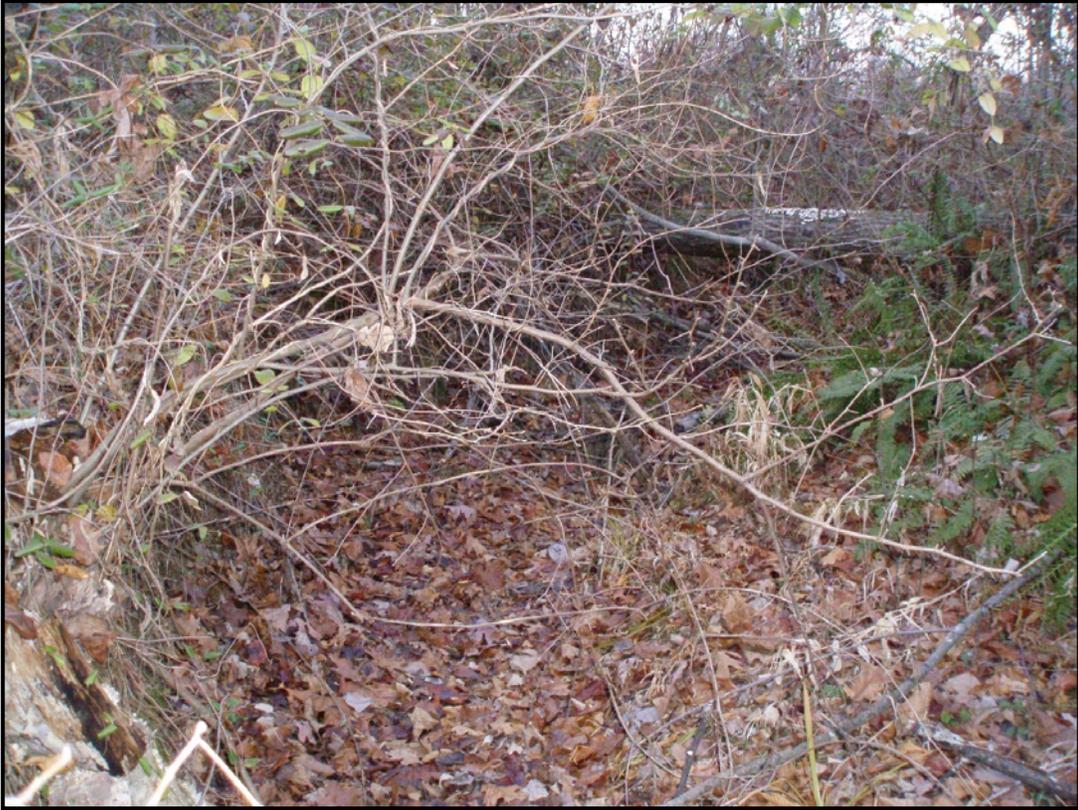
Intermittent 2 (I-2) – Looking upstream

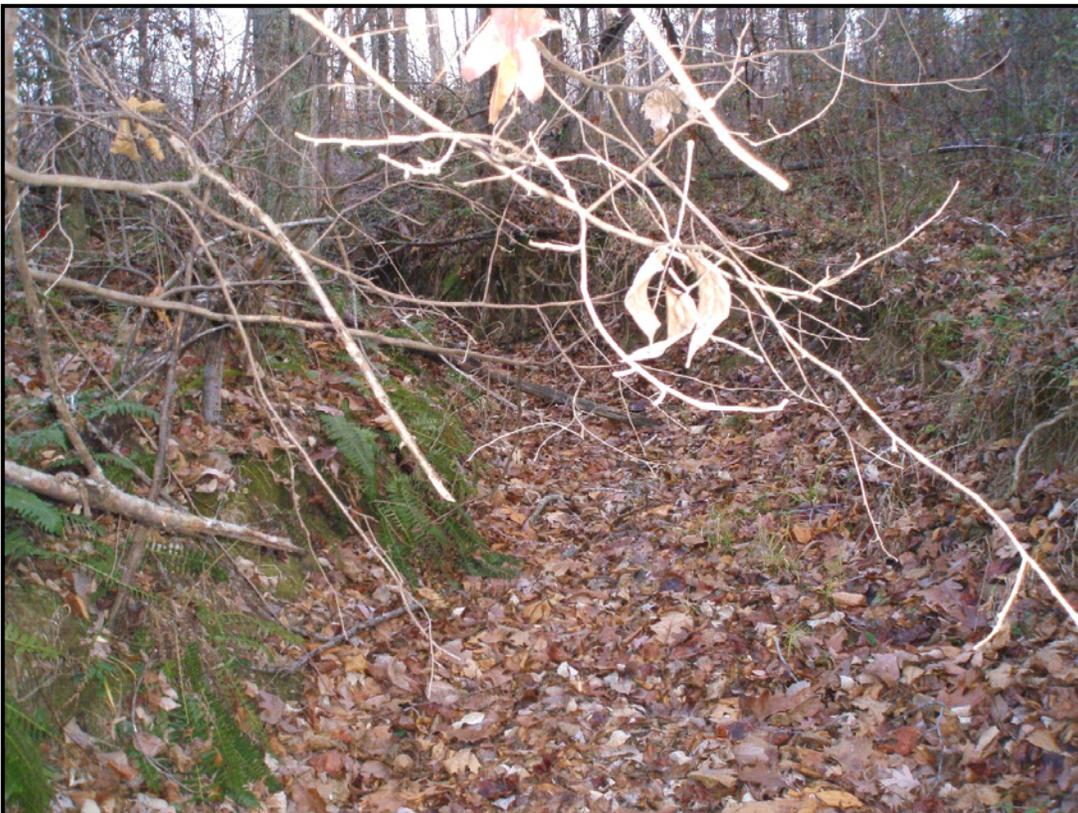
Intermittent 2 (I-2) – Downstream Section (DS), looking downstream

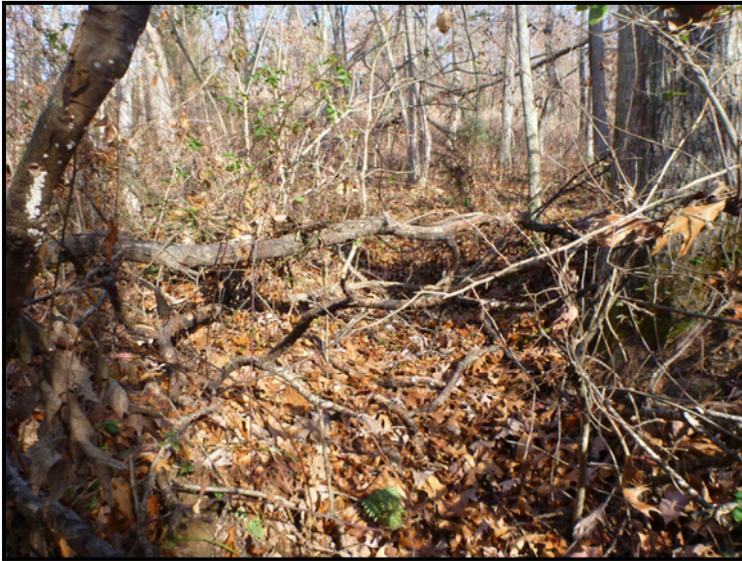
Ephemeral 1 (E-1) – Upstream Section (US), looking upstream

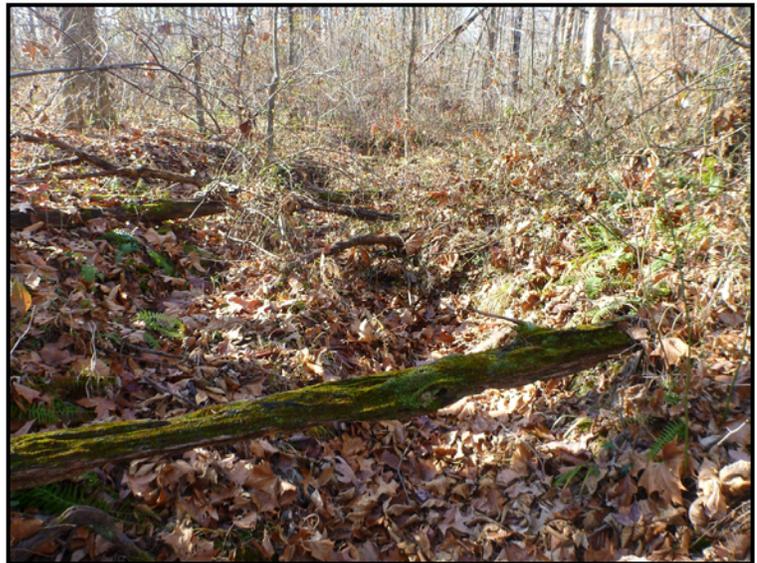
Ephemeral 1 (E-1) – Downstream Section (US), looking downstream

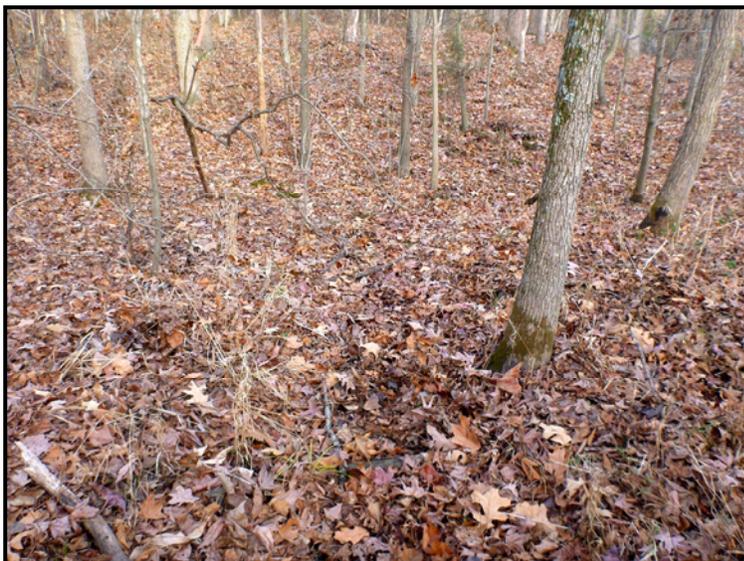
Ephemeral 5 (E-5) – Upstream Section (US), looking downstream

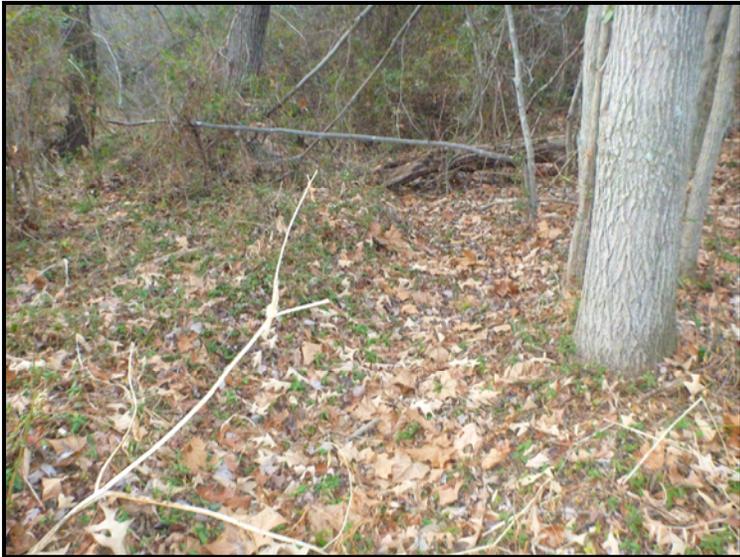
E-5 has an average total habitat score of 105, corresponding to a stream quality rating of low suboptimal. A conductivity reading was not taken due to low flow conditions. E-5 classified as an "E" type stream throughout.

Ephemeral 5 (E-5) – Downstream Section (DS), looking upstream

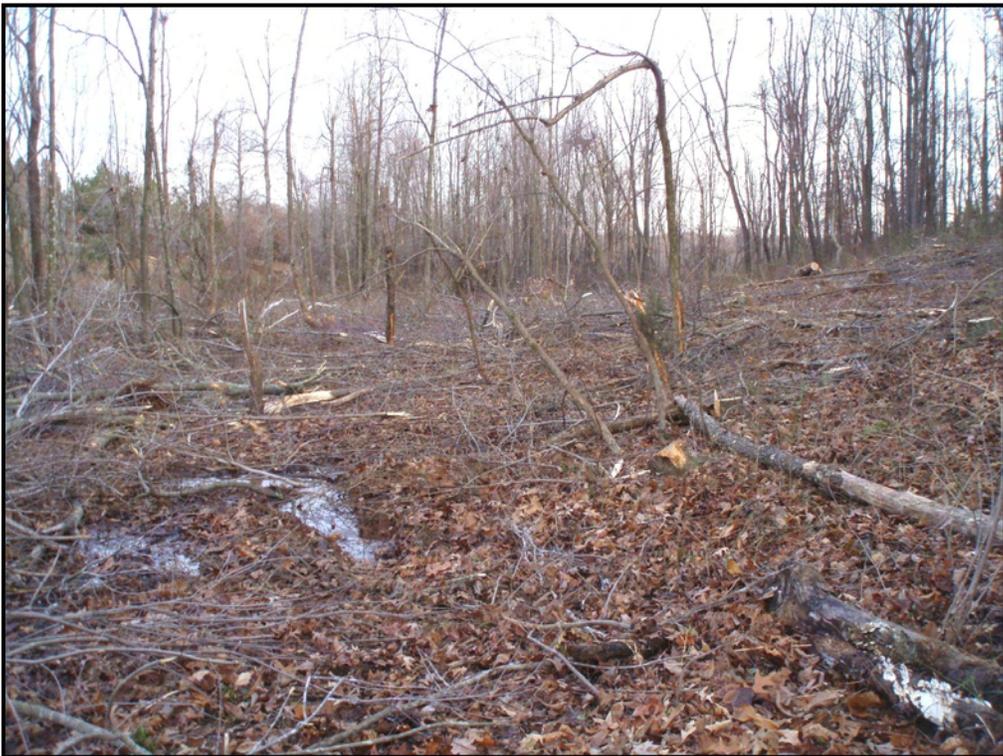
Wetland D

**Wetland D** is located within a swale adjacent to tributary I-2, and is a palustrine, forested wetland that is temporarily flooded (PFO1A). The wetland has a total area of 0.397 acres, and is drained by tributary I-2. The dominant tree stratum species are red maple (*Acer rubrum*), sycamore (*Platanus occidentalis*) and sweetgum (*Liquidambar styraciflua*). The dominant sapling stratum species are spicebush (*Lindera benzoin*), *A. rubrum*, *L. styraciflua* and elderberry (*Sambucus sp.*). The dominant herbaceous species are goldenrod (*Solidago sp.*) and Christmas fern (*Polystichum acrostichoides*). Hydrophytic vegetation is established by the Dominance Test. This area had been recently logged; therefore, soils and vegetation were both significantly disturbed. The soil has a silt-clay loam texture, with a matrix color of 2.5 YR 4/1 and a redox feature of 2.5YR 4/6 from 0 to 6 inches, a matrix color of 2.5YR 4/2 and a redox feature of 2.5YR 4/6 from 6 to 8 inches, and a matrix color of 2.5YR 4/2 and a redox feature of 2.5YR 4/6 from 8 to 12 inches; soils examined satisfy hydric soil indicator F3:Depleted Matrix. The presence of surface water, a shallow water table and saturation are primary indicators establishing wetland hydrology.
